Damage tolerance of impacted curved panels

L. Ballère^{a,*}, P. Viot^a, J.-L. Lataillade^a, L. Guillaumat^a, S. Cloutet^b

The final aim of this study is to evaluate the influence of impact damage on the residual strength of carbon/epoxy vessels stressed by internal pressure. An intermediate stage determined the residual behaviour of pre-impacted curved panels loaded in tension. Curved panels were impacted, reproducing the damage types observed in impacted vessels filled with propellant. Delamination damage was assessed by ultrasonics and optical microscopy used to observe intra-laminar mechanisms. Tension after impact (TAI) tests quantified the residual behaviour. An experimental design was used as an alternative to the complex analytical modelling of dynamic damage mechanisms. With this original technique, empirical relationships were established, linking impact parameters to residual properties. The force to failure was found to vary in a bi-linear manner with impact energy. Below a specific level of impact energy corresponding to failure in 4/7 of the plies, there is no significant reduction in the residual strength. The composite Young's modulus decreased linearly with impact

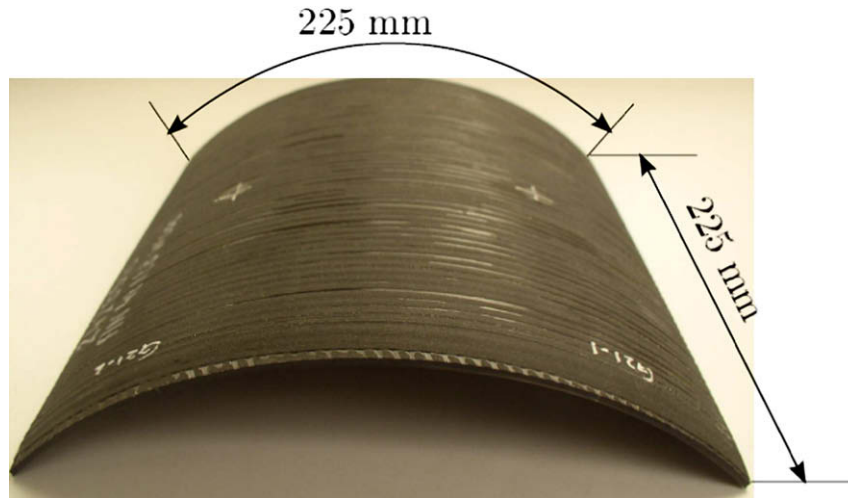
Fig. 1. Specimen.

After the unit is processed in a heater to cure the resin, the mandrel and the laminate are separated, and the tube is cut into specimens which are 225 mm \times 225 mm in size (see Fig. 1). As a result of cutting, internal stresses from the manufacturing process are released. This leads to a reduction in the radius of curvature to about 278 mm, and some twisting of the panel.

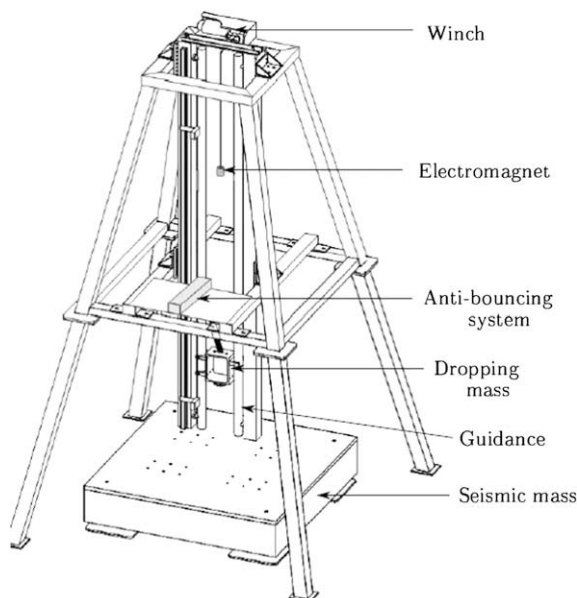
Fig. 2. Global drop tower.

An evaluation of potential risks has made it possible to focus the study on low energy impacts such as the dropping of tools. A laboratory drop tower performed these impact tests (Figs. 2 and 3). The specimen is placed in an assembly, clamped to a seismic mass. The drop mass is guided by two vertical columns during the test. A hemispherical indenter, fixed on this mass, has diameter 16 mm. A winch raises the drop mass to the desired height, then an

electromagnet releases the mass. After the first impact, an anti-bouncing system prevents a second impact.

Sensors are used to measure the impact parameters, and to study the damage phenomena. A piezoelectric force sensor, close to the indenter, measures the contact force between the striker and the specimen. A laser sensor measures the impactor displacement, which includes the indentation depth. Even though the drop height and the falling mass are precisely measured, the impact energy is not equal to the decrease in the drop-mass potential energy, due to friction in the bearings. The impact kinetic energy was obtained from the velocity just prior to impact, which was obtained from the time derivative of the displacement history. Signals from these sensors are taken to a signal conditioner and converted into digital form.

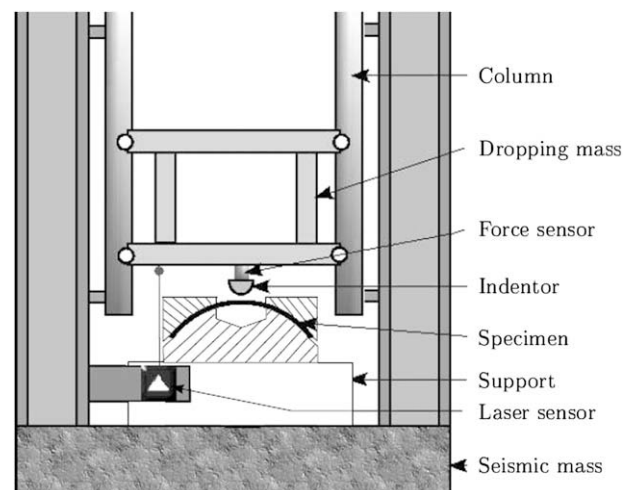
Fig. 3. Detailed drop tower.

In order to avoid punching, the sharp-edges of the window are chamfered. The assembly is then placed on the drop tower support (Fig. 3).

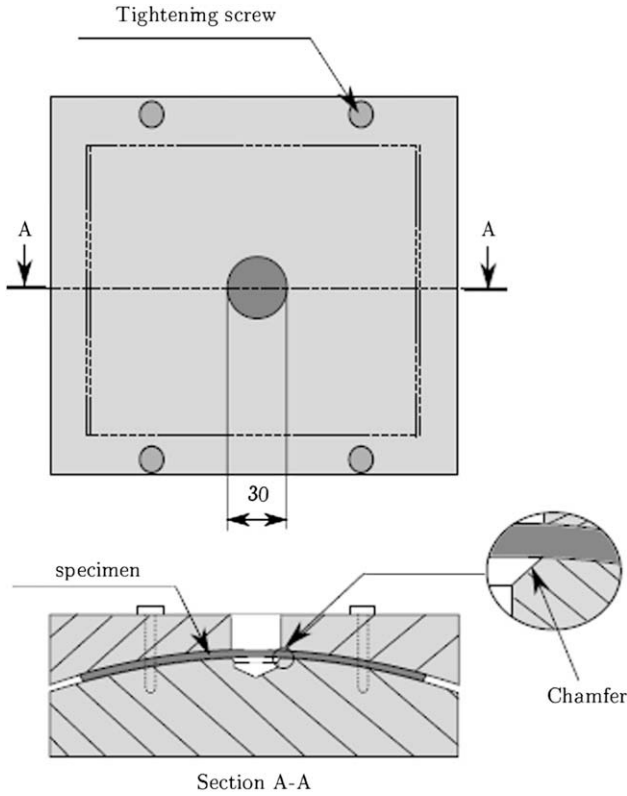
Fig. 4. Specimen mounting device.

The main damage mechanism observed during the low energy impacts is delamination. Fibre failure occurs at higher energies, accompanied by a significant delaminated zone. For composite vessels subjected to an internal pressure, the most critical damage mechanism is fibre failure. Since the specimens are stressed in tension after impact (to reproduce real loading) fibre failure must be favoured, and the delamination zone limited. This also limits the interaction between delamination and free edge effects [13]. In order to restrict the damage to a zone close to the impact point, a special device gripped the specimen: Fig. 4. The specimen is clamped between two aluminium blocks, tightened with screws. The tightening torque value was chosen by trial and error to achieve good specimen locking and avoid inside face peening.

The specimen is therefore, fully supported on both surfaces except for a circular region of 30 mm in diameter in the centre, restricting the delamination damage to within this zone. Poe [5] showed that, for composite rings filled with propellant and subjected to impact, the damage is localized to a region directly beneath the impact site. This remark reinforced the choice of the window diameter (30 mm) which is close to the impactor diameter (16 mm). Although a rectangular shape of this window would have been more in line with the specimen support than this circular shape, the latter was chosen to reproduce the damage shape observed in impacted composite rings filled with propellant. Moreover, the tightening conditions make the influence of the square shape of the support in the impact area negligible.

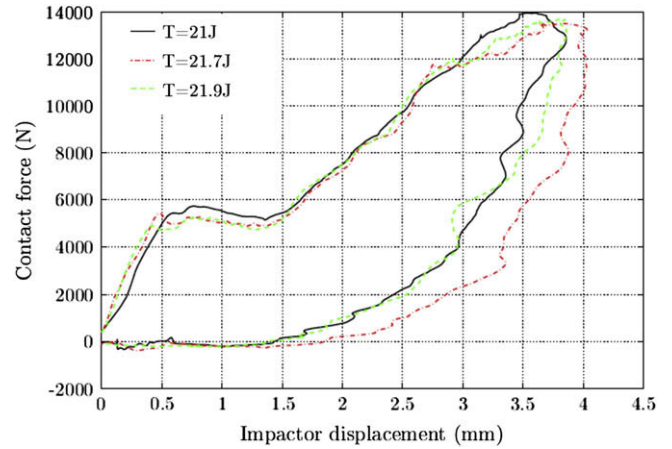
Fig. 5. Repeatability of the specimen responses in the case of a moderate damage.

Three repeat impact tests were used to establish the relation between the damage and the residual tensile strength. There is good repeatability of the specimen response in the impact tests. Figs. 5 and 6, respectively, show the response of three specimens for impact experiment no. 3 (the lowest energy level) and experiment no. 4 (the highest energy level). Each figure shows the contact force variation with the impactor displacement. These two energy levels, at the bounds of the experimental design, were analyzed to find the influence of the damage on the repeatability of the specimen response.

The energy level represented in Fig. 5 corresponds to a damage which cannot be detected by visual inspection. The maximum variation in kinetic energy, of about 4.2%, is caused by a variation in the impact velocity due to variable friction in the bearings on the guidance columns (Fig. 3) (the maximum variation in velocity is 2.1%). With such a low variation in the impact velocity, the response of the specimens is similar. The shape is approximately the same, with three stages: (i) an initial force peak when the impactor contacts the specimen, (ii) a force increase to a maximum, and (iii) specimen unloading. The variation in the maximum force is 1.9% and in the maximum displacement is 4.3%. This demonstrates the repeatability of the specimen responses when there is moderate damage.

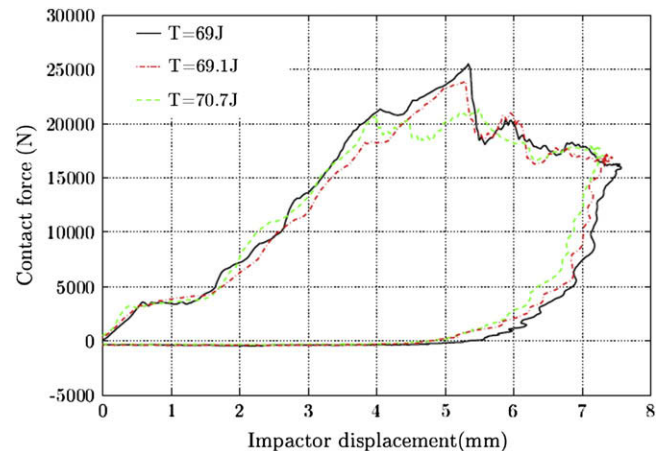
Fig. 6. Repeatability of the specimen responses in the case of a pronounced damage.

Fig. 6 shows the specimen response during impact tests performed with an energy of about 70 J, in which the specimen is severely damaged. As previously found the variation in the impact velocity is small; it is 0.04 ms^{-1} , or 1.2% and the variation in kinetic energy is 2.4%. As previously found, the response is similar for the three specimens. For each test, the shape of the force/displacement curve consists of the first two stages described previously, then, (iii) pronounced damage where the force keeps a quasi-constant, plateau value and finally, the specimen unloading. The variation of the maximum force is 16.4% and that of the maximum displacement is 3%. Although the observed force variation is rather significant, two of the three specimens exhibit a variation equal to 6%. Since the fracture of composite materials is generally dispersed, the repeatability of the specimen response in the case of a pronounced damage can be considered acceptable.

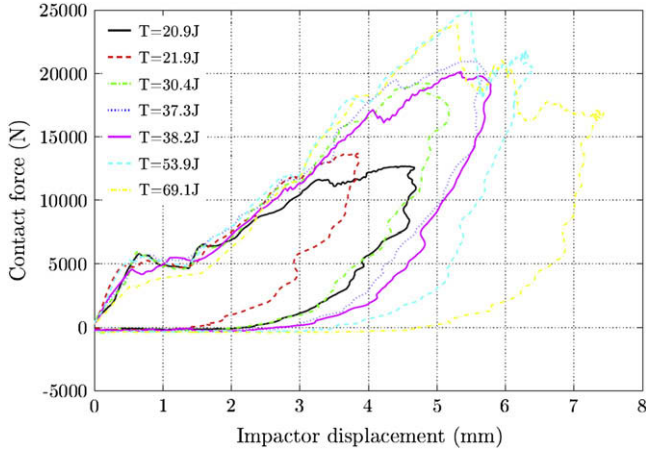
Fig. 7. Force/displacement curves of specimens stressed by impact.

Since the specimen behaviour has a low uncertainty, it is possible to conduct the previously described test campaign associated with the experimental design. Fig. 7 illustrates the contact force variation with impactor displacement. Since repeatability was demonstrated in the previous subsection, for clarity only one test for each point of the experimental design is presented in this figure.

As mentioned before, for each mass/velocity couple, a first force peak is observed and it keeps a quasi-constant value. The maximum contact force then increases with the impact energy in a non-linear

way. From low energy levels (22 J at Point A), an impact energy increase by 29% to Point B causes a strong increase in the contact force (29%). It is difficult to be sure that this increase is only due to the kinetic energy increase. It would be wiser to consider the influence of the mass and the velocity separately. However, from a higher energy level of 54 J, at Point C, an increase of 22% of the kinetic energy (Point D) only causes a 4.5% increase in the maximum force. This non-linearity of response is illustrated in Fig. 8. Although higher energy levels were not investigated, the maximum force seems to tend to an asymptotic value of about 25,000 N. This level corresponds to the maximum force that can be sustained by the structure in this test configuration.

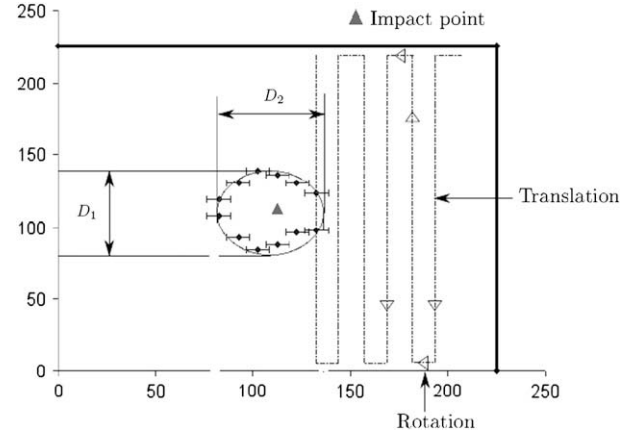
Fig. 9. Ultrasonic inspection result.

The specimen was set on a C-channel with the concave face upwards completely immersed in water, in an ultrasonic tank. The diameter of the ultrasonic transducer was 6 mm. It was non-focused and its frequency was 10 MHz. The transducer axis is normal to the axis of the cylindrical specimen (normal incidence) and the specimen was scanned parallel to the cylinder axis. The resulting signal, observed on an oscilloscope screen, detects the beginning and the end of delamination. The specimen is then rotated about the cylinder axis and scanned again parallel to that axis. The step between two scans is 10 mm.

Fig. 9 illustrates the typical result obtained by this technique. The specimen dimensions (225 mm × 225 mm) are shown and the

triangle at the centre corresponds to the impact point. The scan lines are vertical. Along each scan line, the two points shown correspond to the upper and lower boundaries of the delaminated zone (distance D_1). The horizontal error bar is the diameter of the transducer i.e. 6 mm. Since the delamination is detected when the signal changes significantly, the vertical error is estimated at 2 mm. We assumed that the delamination zone has a circular shape (i.e. $D_2 = D_1$). This assumption is verified by optical microscopy presented in the following subsection. The error on the diameter is estimated at 2 mm.

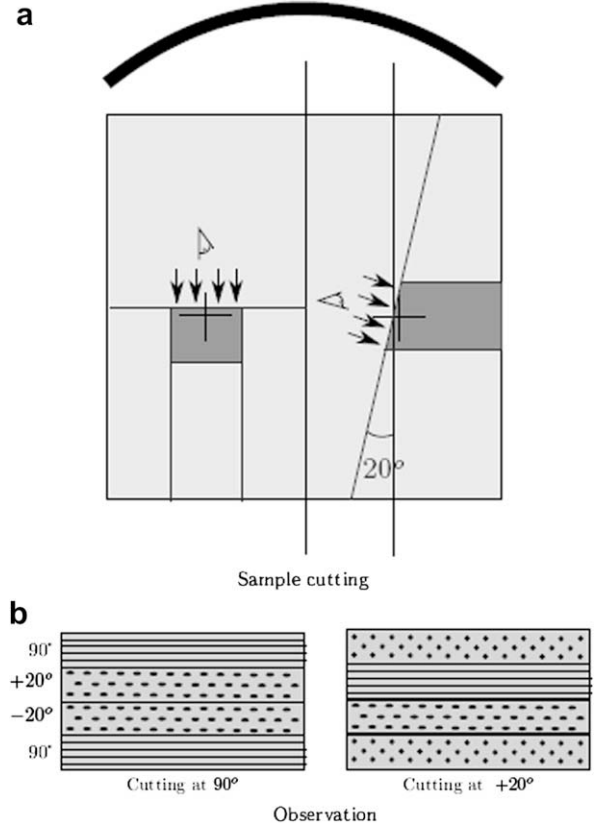
Fig. 10. Procedure for microscopic observation.

The appearance of polished samples (Fig. 10b), changes according to the cutting orientation. When cut parallel to circumferential fibres (oriented at 90°), these fibres look more or less like continuous lines, while the longitudinal fibres have elliptical cross-sections.

When cut parallel to the longitudinal fibres (for example $+20^\circ$), these appear as continuous lines while those oriented at -20° , have elliptical cross-sections. Circumferential fibres appear with a more or less circular cross-section.

The specimens are cut with a diamond circular saw, with a high rotation velocity and a very low feed velocity, to limit damage. To observe the failure of the circumferential fibres, the sample was sectioned circumferentially, as shown on the left side of Fig. 10a. To observe longitudinal fibres, the sectioning was done along the 20° fibre angle, as shown on the right side of Fig. 10a.

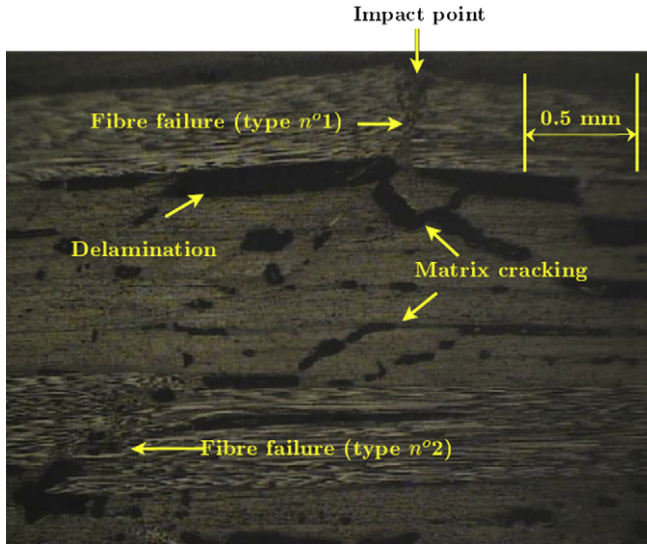
Fig. 11. Microscopic observation presenting the damage mechanisms observed.

With the specimen mounting device used in this study, many damage mechanisms appear as shown in Fig. 11. One can observe delamination, matrix cracking, and fibre failures. Particular attention was paid to fibre fracture since this is the most critical damage mechanism for the tension strength. Three types of fibre failures can be observed: (i) those due to local shear stresses (type no. 1, Fig. 11), (ii) self-organized failures linked to bending stresses (i.e. kink-bands [17]) and, (iii) failures without any organization (type no. 2, Fig. 11).

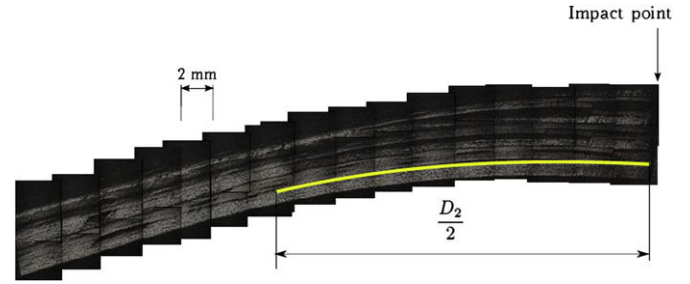
Fig. 12. Microscopic observation presenting the delamination observed.

Cutting along the circumferential fibres made it possible to verify the assumption of a circular shape delamination zone, as shown in Fig. 12. Measuring the size of the larger delamination (highlighted in this figure) which corresponds to the projected zone measured by ultrasonics, it is possible to affirm that the distance D_2 is equal to $D_1 \pm 2 \text{ mm}$ (Fig. 9) for each impact energy level. Hence the delamination zone is always included in a cylinder of $30 \pm 2 \text{ mm}$ in diameter.

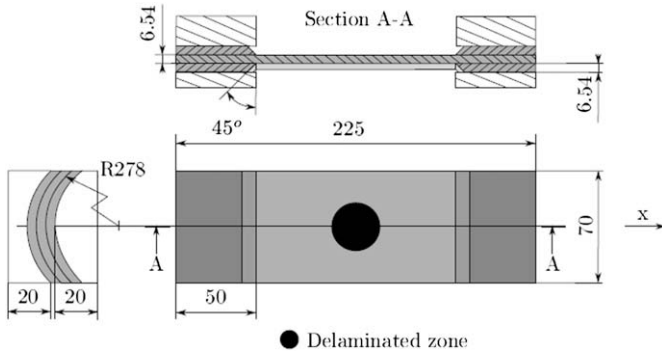
Fig. 13. Geometry of the tensile specimens.

Since the projected area of the delaminated zone was determined by ultrasonics, the 225 mm × 225 mm specimens were cut, with a diamond saw, on both sides of the damage zone to obtain a 225 mm × 70 mm specimen (see Fig. 13). Undamaged specimens were also cut to the same dimensions. Reinforcement tabs were cut from similar material with the same thickness and

curvature. Their dimensions are 70 × 50 mm and they are chamfered on one of the 70 mm lengths at a 45° angle to minimize the effect of shear stresses. The tabs were bonded to the specimen with an epoxy resin. The assembly is then pressed for 24 h for the adhesive to cure. The interface between the jaws of the tensile machine and the curved assembly is made of aluminium parts, which ensure uniform tightening on the tabs during the tensile test. In order to avoid slipping between the aluminium parts and the carbon/epoxy tabs, they are also bonded with the same epoxy resin and subjected to uniform pressure for 24 h for the glue to cure. The assembly, aligned with the jaws of the tensile machine, is detailed in Fig. 13.

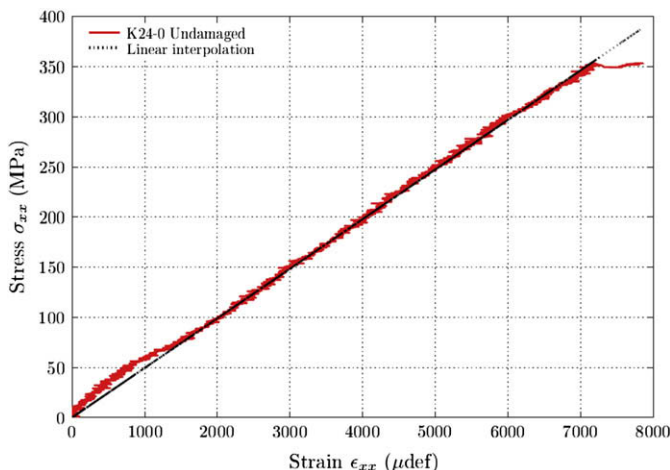
Fig. 14. Typical stress-strain curve in the case of undamaged specimens.

Since the aim of this study is to quantify the residual tensile strength variation of damaged specimens compared to undamaged ones, a first series of runs was conducted on non-damaged specimens. A typical stress-strain curve is shown in Fig. 14 together with the straight-line fit used to calculate the mean homogenized elastic modulus. The behaviour of undamaged specimens can be considered quasi-linear. Nevertheless, one can observe slope variations of the stress vs strain curve. During the tensile tests, due to the lay-up and the boundary conditions, the specimen curvature tends to increase between the jaws. Therefore, for a strain value close to 1000 µdef, circumferential layers (i.e. 90° oriented) are progressively damaged according to the interfibre mode causing the

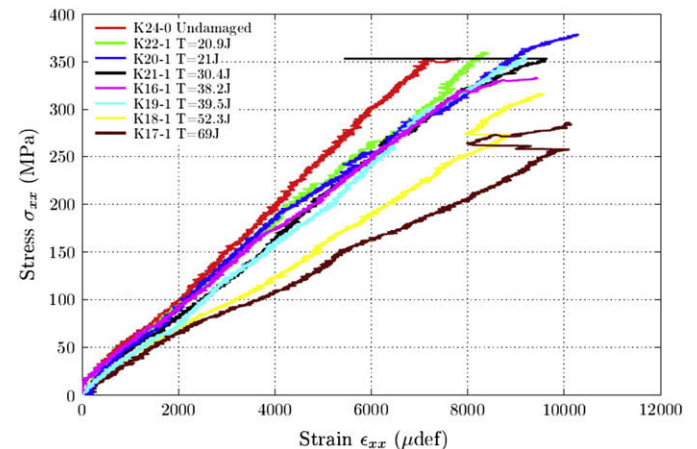
Fig. 15. Stress-strain curves corresponding to quasi-static tests on pre-impacted specimens.

The influence of different amounts of impact damage on the residual tensile behaviour of the specimens is illustrated in Fig. 15.

The reference curve is for an undamaged specimen. There is a global decrease of the mean homogenized elastic modulus according to the initial damage state of the specimens. The previously described phenomenon, which explain the variation in slope of the stress-strain curves at the beginning of the test, occurs for each test of pre-damaged specimens. Other variations in elastic modulus occur during the tests of damaged specimens. These are amplified by the initial damage state. It can be assumed that the damage initiated by impact generates a local anisotropy which leads to a modification of the specimen behaviour during tensile tests.

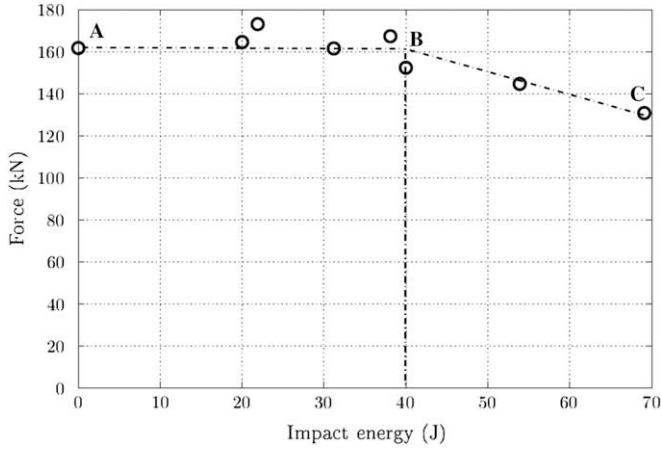
Fig. 16. Force vs impact energy curves corresponding to quasi-static tests on pre-impacted specimens.

The impact damage influences the residual tensile strength of the specimens. Fig. 16 shows the variation of the maximum force to failure with the impact energy. Point A, for undamaged specimens occurs at the mean force presented in Table 4. For impact energies lower than 40 J, the damage seems to have no significant influence on the residual tensile strength. This energy level corresponds to failure of 4/7 of the plies (50% of these plies are oriented at 90°), in a cylindrical zone 30 mm in diameter at the specimen center. From this energy level, the maximum force to failure starts to decrease until the maximum impact energy level at which all the plies are failed. At this point, the loss of strength with respect to the undamaged specimens is 18.6%. One can note that, while Table 3 shows the similar degree of fibre fracture for impact energies of 40 J and 53 J, there is no reduction of the residual tensile strength for the first energy level. We assume that the force to failure depends, both on the number of failed layers and the location, through the thickness, of the fibre failures.

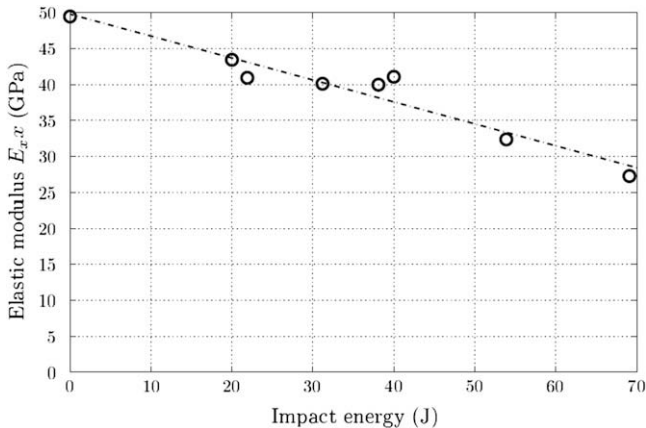
Fig. 17. Homogenized elastic modulus vs impact energy for quasi-static tests on pre-impacted specimens.

While the failure force vs impact energy graph consists of two linear regions, the homogenized elastic modulus seems to decrease

linearly with impact energy (Fig. 17). The elastic modulus of undamaged specimens is presented in Table 4. The maximum loss of elastic modulus, for the highest energy level of 69 J, is 46%. Considering that the longitudinal elastic modulus is mainly determined by the longitudinal fibres, this reduction seems acceptable when most of the fibres have failed.

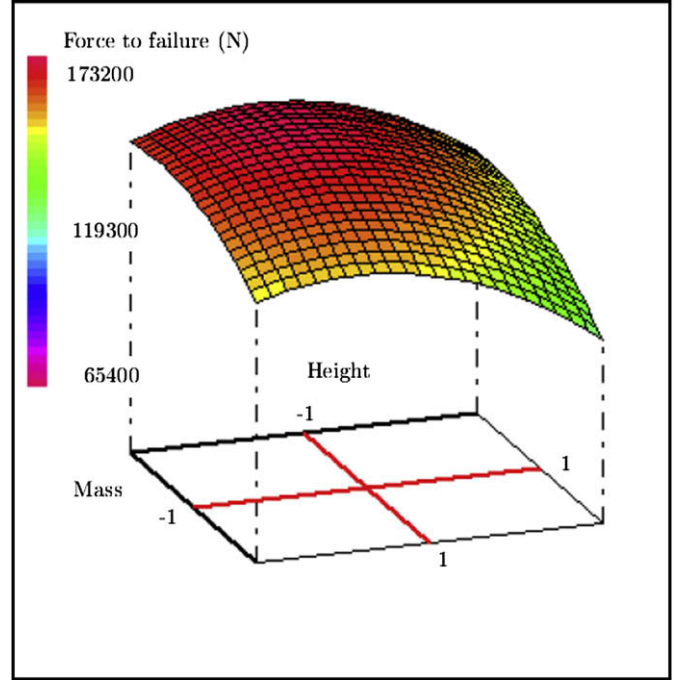
Fig. 18. Isovalues of the response surface corresponding to quasi-static tests on pre-impacted specimens.

The residual force to failure as a function of the impact mass and the drop height is shown by the response surface in Fig. 18. This plot, directly established from the experimental design analysis, indicates the influence of each input parameter on the force to failure. Therefore, one can note that there is not a preponderant parameter on the residual tensile strength.
